Norton Model 50, Slimline frame, 1961 engine sprocket details.

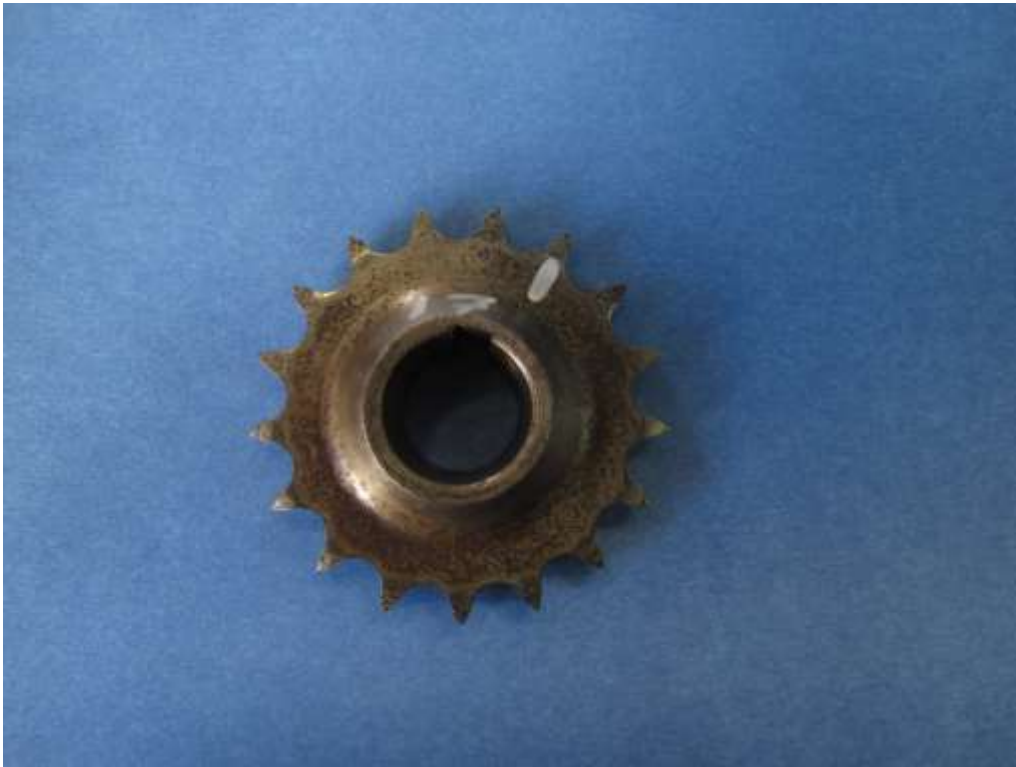
Figure one. Engine sprocket, crankcase side view, 17 teeth.

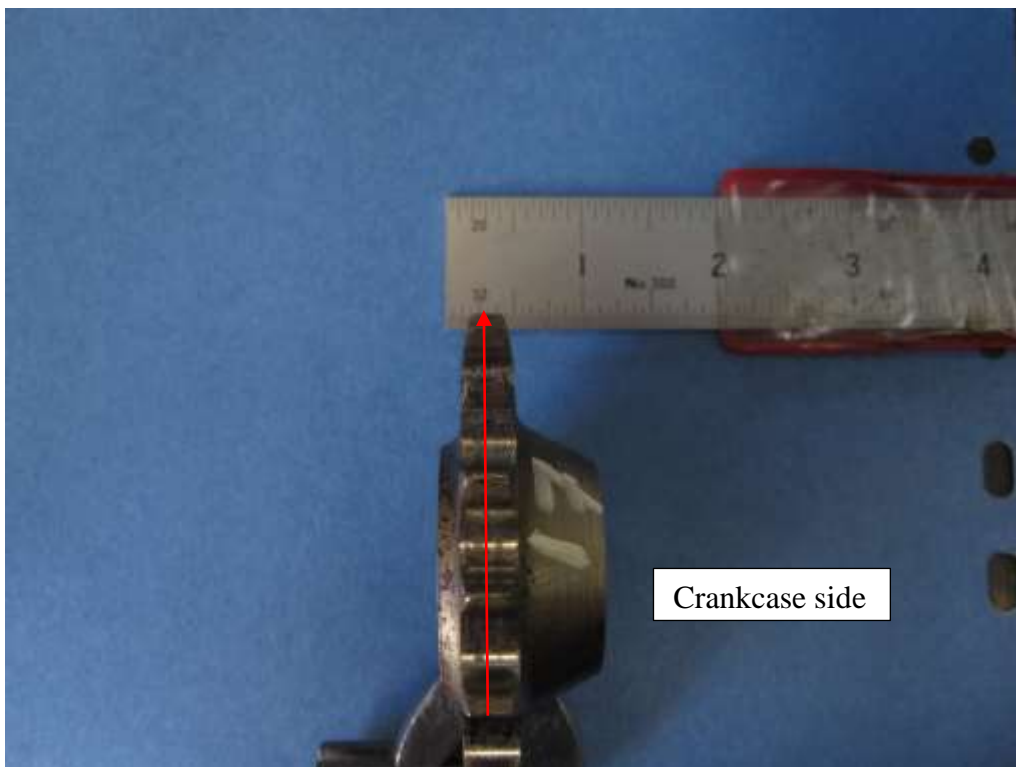
Figure two. Engine sprocket, top view, 17 teeth; *center line* of chain path appears to be ~ 1" in from the crank case side and ~1/4" from primary case / alternator rotor.
