More on Lightweight Main Bearings

Some pictures of actual Jubilee/Navigator/Electra main bearings

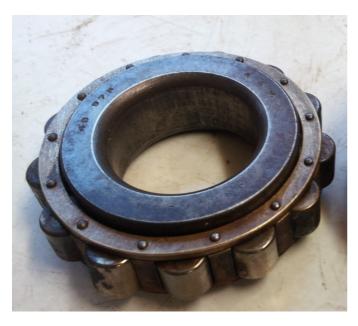
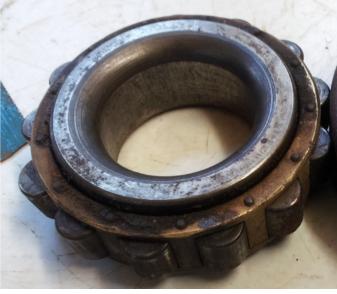
- 1) (L) this shows the normal 0.090" chamfer on the 'outer' face of the Drive Side main bearing,
- 2) (R) the special 0.125" chamfer on the 'inner' face is clearly visible.

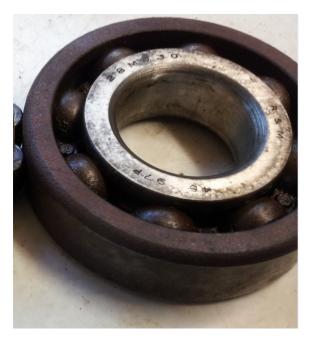
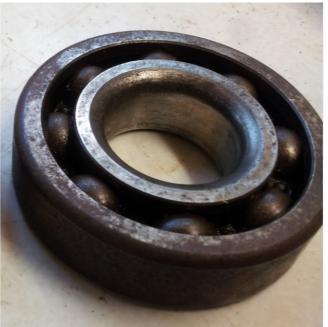
- 1) (L) this shows the normal $0.090^{\circ\prime}$ chamfer on the 'outer' face of the Timing Side main bearing,
- 2) (R) the special 0.125" chamfer on the 'inner' face is clearly visible.
